Australian Tree Care – TAS

ABRIDGED INTERIM REPORT, REGENT SQUARE, AVENUE OF POPLARS

Brief: Present an abridged interim report on the avenue of Poplars located over and beside a concrete pathway in Regent Square.

The trees were visually inspected from ground level on 9/08/14.

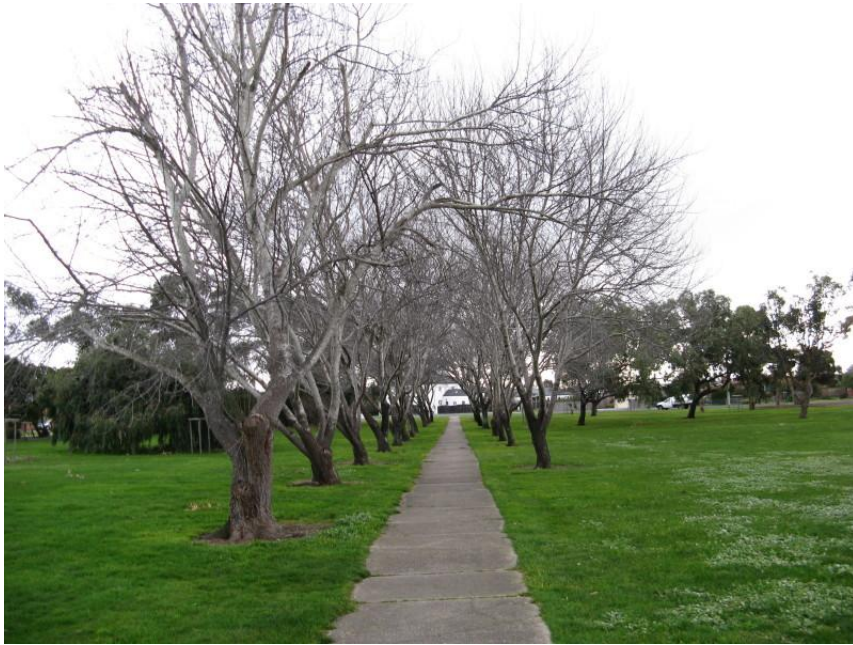
some specimens exhibit pronounced leans indicative of failing root plates due to high winds and water logged grounds

Showing leans and extended limbs

In brief, I suggest that there are a total of 9 trees that need to be removed from the avenue because of health and structural issues (as outlined above).

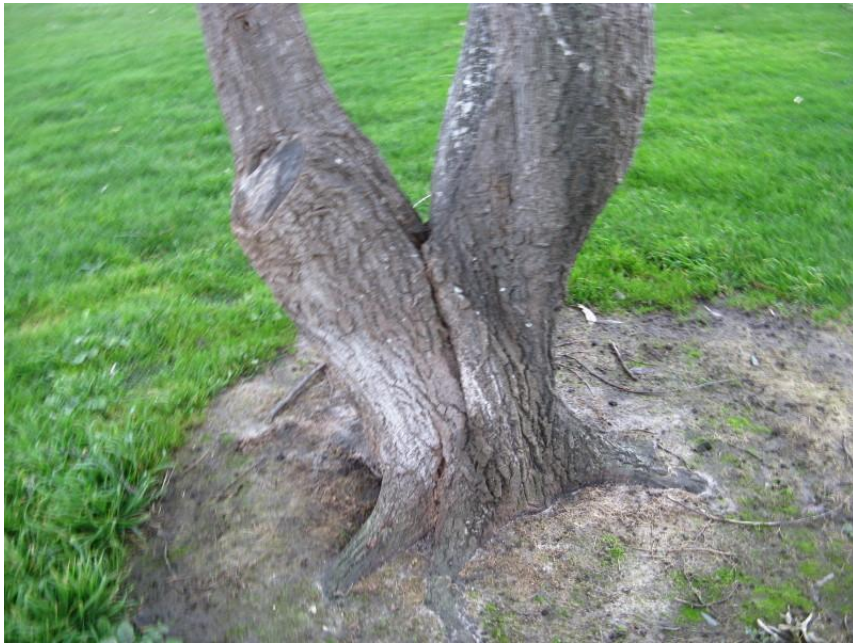
Structure – poor to good, some specimens exhibit significant bark inclusions (an inherent weakness of compressed bark located in the fork of a trunk, limb or branch which may predispose the structure to failure), some specimens exhibit elongated weight loaded lateral limbs and branches which can be predisposed to failure in strong weather conditions, some specimens exhibit diseased and degraded trunks and limbs (some have a combination of all the above)

Example of bark inclusion

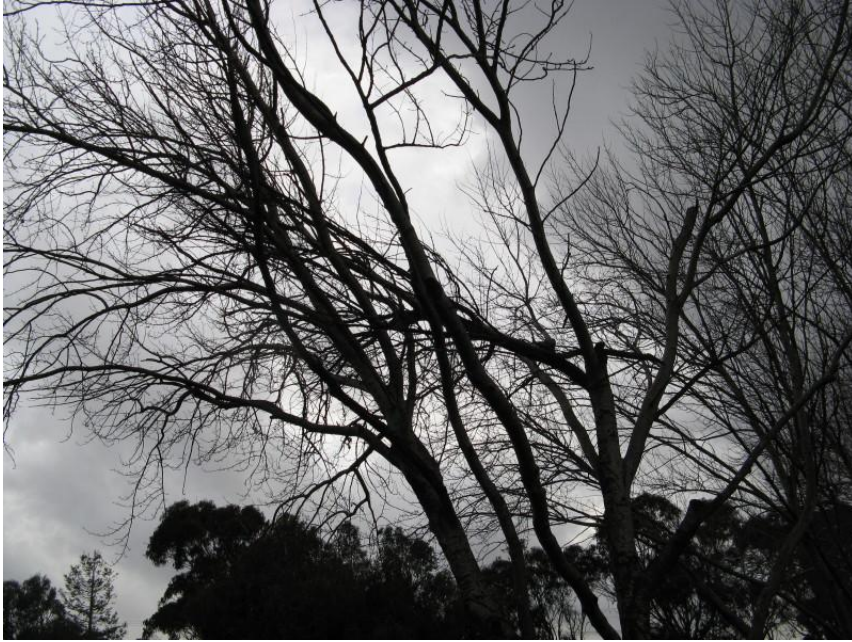
Example of failed branch suspended in degraded canopy

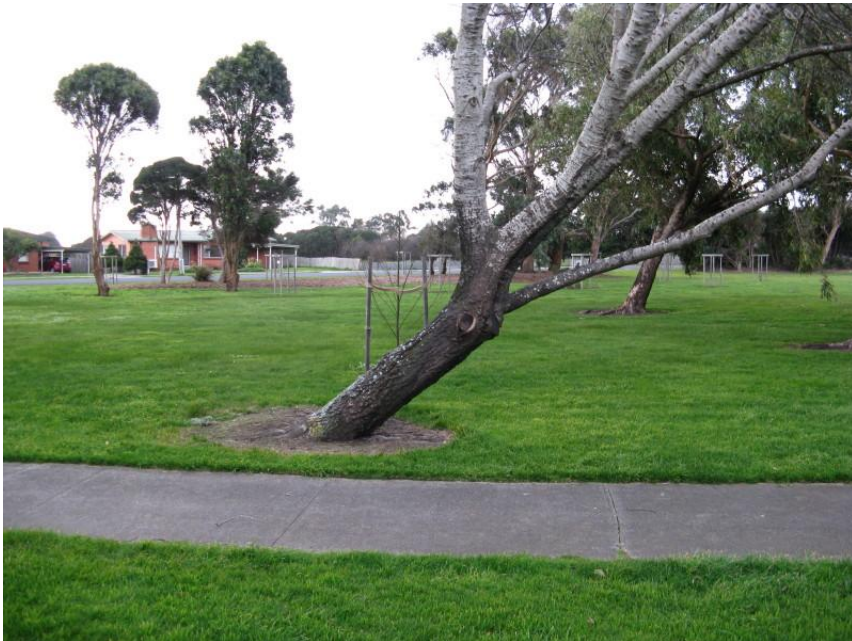
Hazardous lean

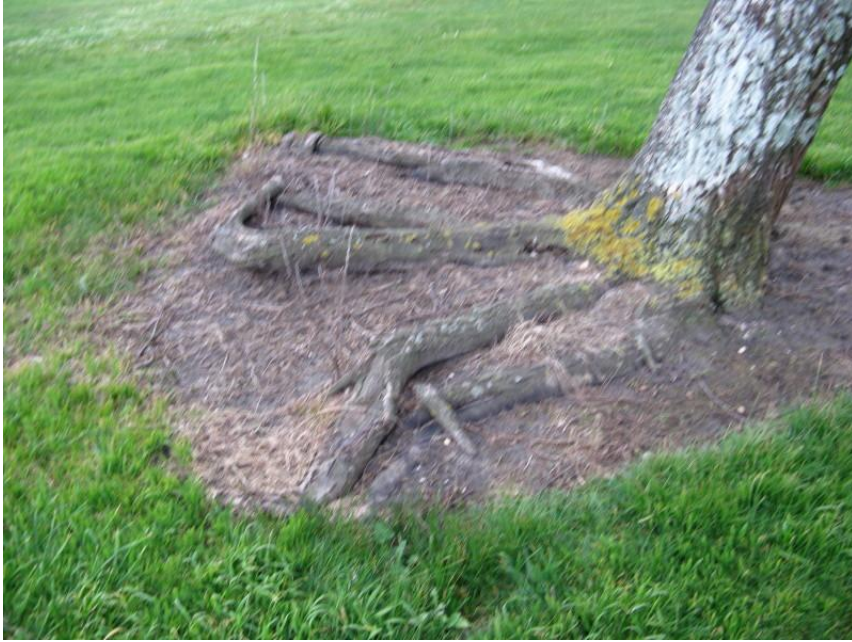
Dimensions – the average Diameter at Breast Height (DBH) is approximately 400 – 500mm, **Height** – averaging 14 meters, **Canopy Spread** – averaging 7-8 meters with canopies shaped to the south and east by strong winds, **Age** – approaching maturity (with potential to almost double in size, with trunks to 2 meters), **Root Plate** – some are poor with exposed roots with some evidence of damage and decay,

Exposed and degraded roots and hazardous lean

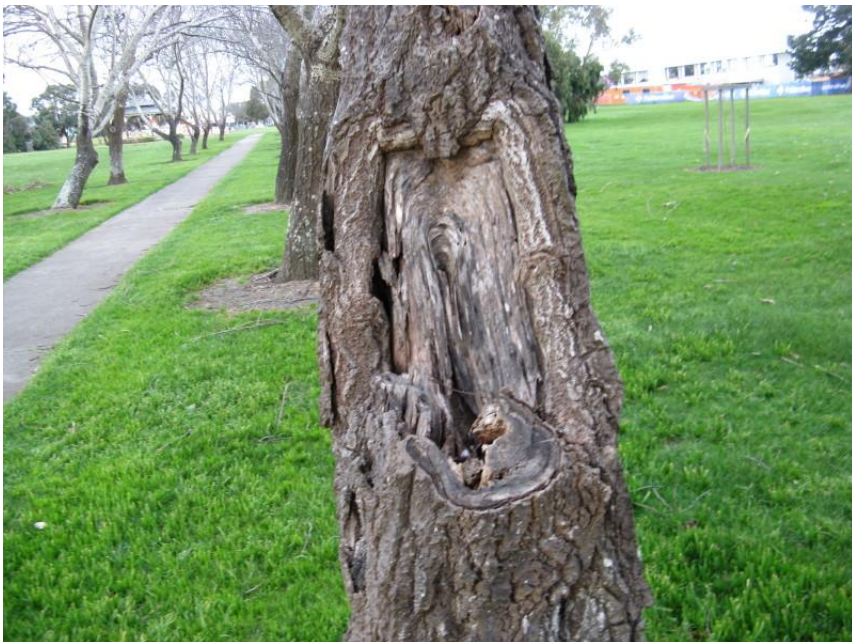
Health – poor to good, some specimens exhibit various amounts of decay in exposed roots and in trunks and limbs

Trunk cavity with fungal pathogen
