Australian Tree Care – TAS

11/08/14

ABRIDGED INTERIM REPORT, REGENT SQUARE, AVENUE OF POPLARS

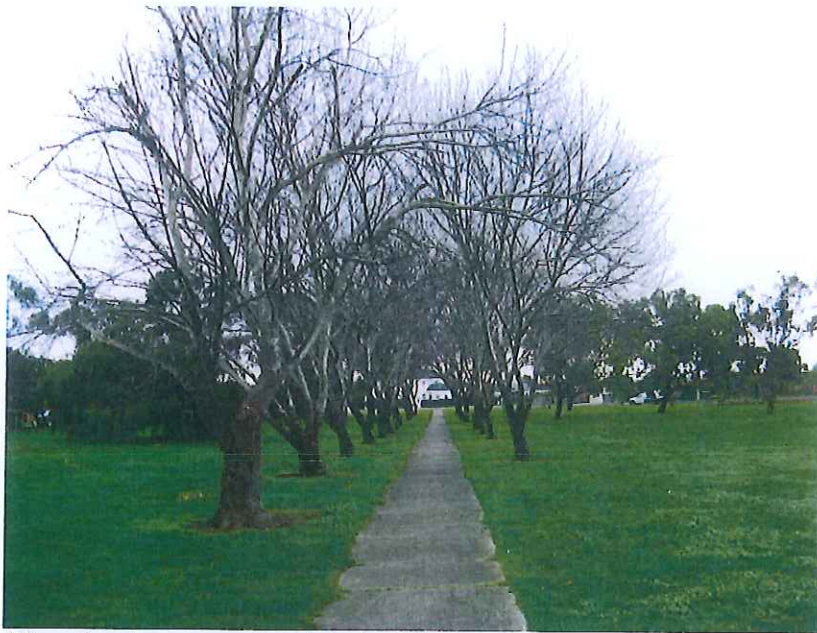
Showing leans and extended limbs

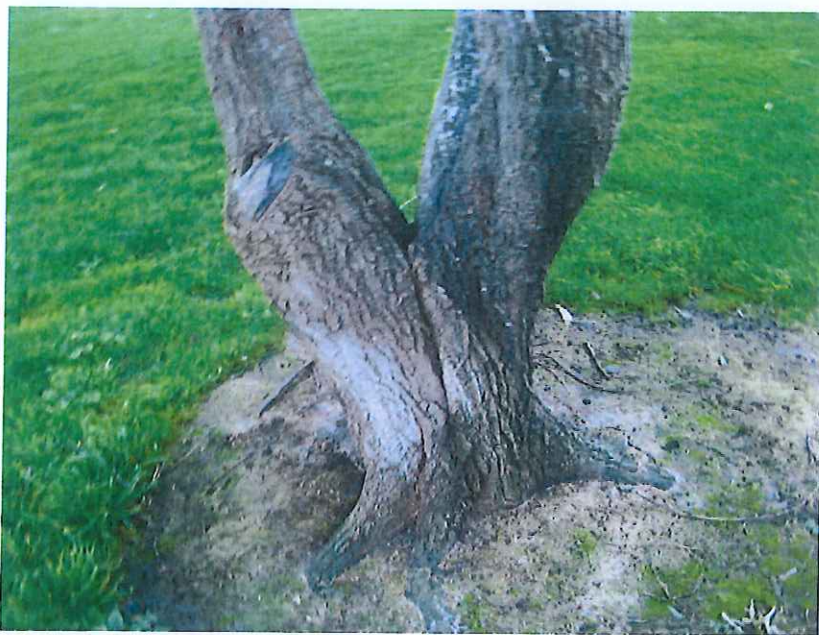
Structure – poor to good, some specimens exhibit significant bark inclusions (an inherent weakness of compressed bark located in the fork of a trunk, limb or branch which may predispose the structure to failure), some specimens exhibit elongated weight loaded lateral limbs and branches which can be predisposed to failure in strong weather conditions, some specimens exhibit diseased and degraded trunks and limbs (some have a combination of all the above)

Example of bark inclusion

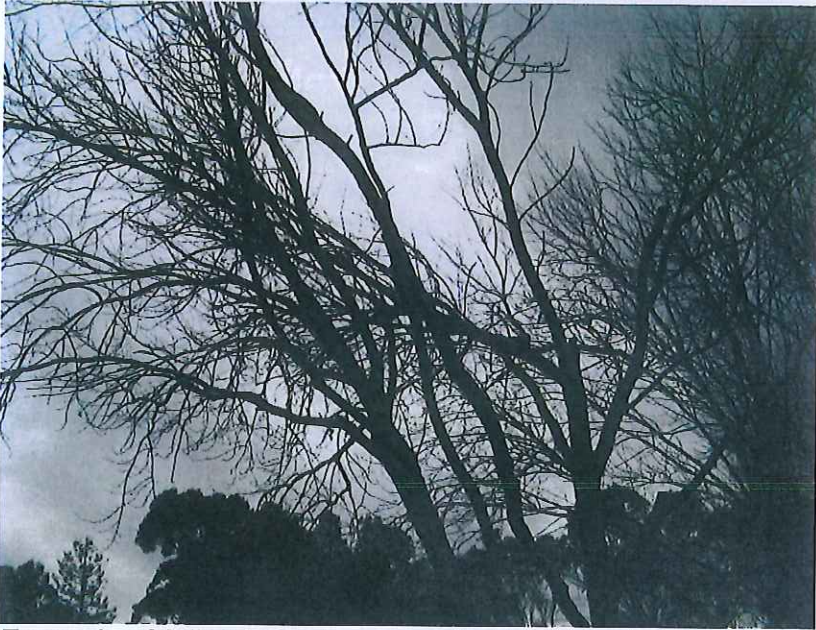
Example of failed branch suspended in degraded canopy

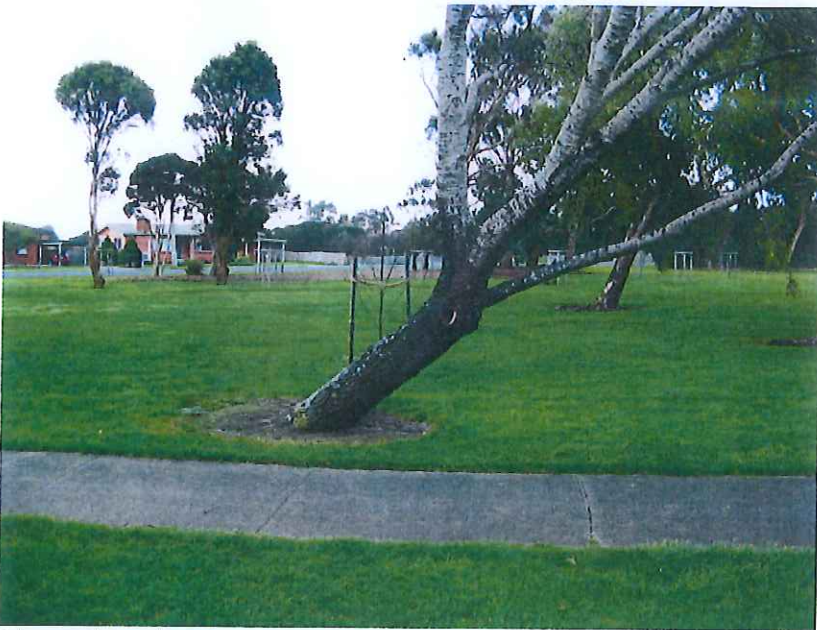
some specimens exhibit pronounced leans indicative of failing root plates due to high winds and water logged grounds

Hazardous lean

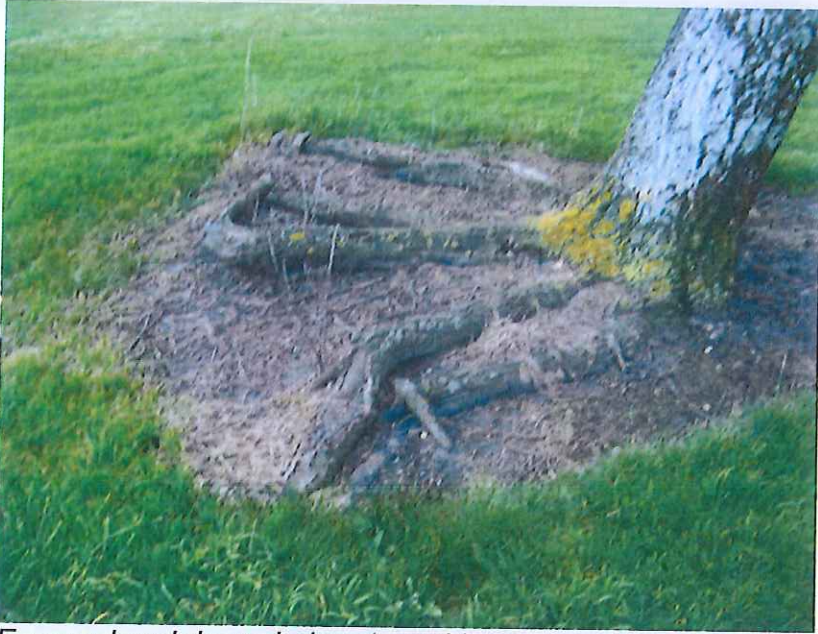
Dimensions – the average Diameter at Breast Height (DBH) is approximately 400 – 500mm, **Height** – averaging 14 meters, **Canopy Spread** – averaging 7-8 meters with canopies shaped to the south and east by strong winds, **Age** – approaching maturity (with potential to almost double in size, with trunks to 2 meters), **Root Plate** – some are poor with exposed roots with some evidence of damage and decay,

Exposed and degraded roots and hazardous lean

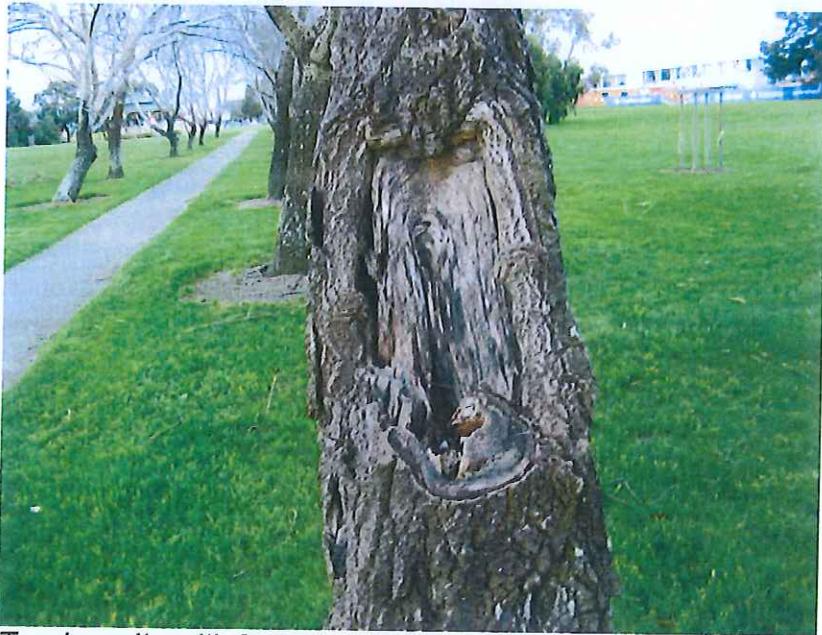
Health – poor to good, some specimens exhibit various amounts of decay in exposed roots and in trunks and limbs

Trunk cavity with fungal pathogen
