Soil and Water Management Control Plan

Hillwood Berries, Hillwood Road, Hillwood

September 2020

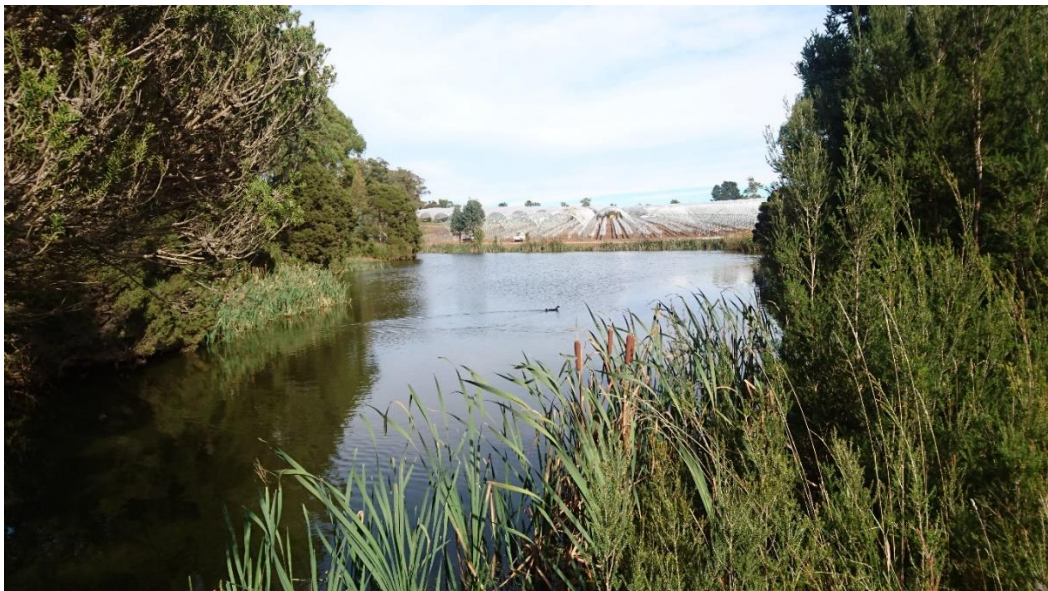
Figure 2 On stream dam in the Macquarie Rivulet

The Macquarie Rivulet and its unnamed tributary converge on the 105 Hillwood property (as owned by the proponent) into a licenced on-stream dam, Permit 3359, which is licenced for irrigation extraction.

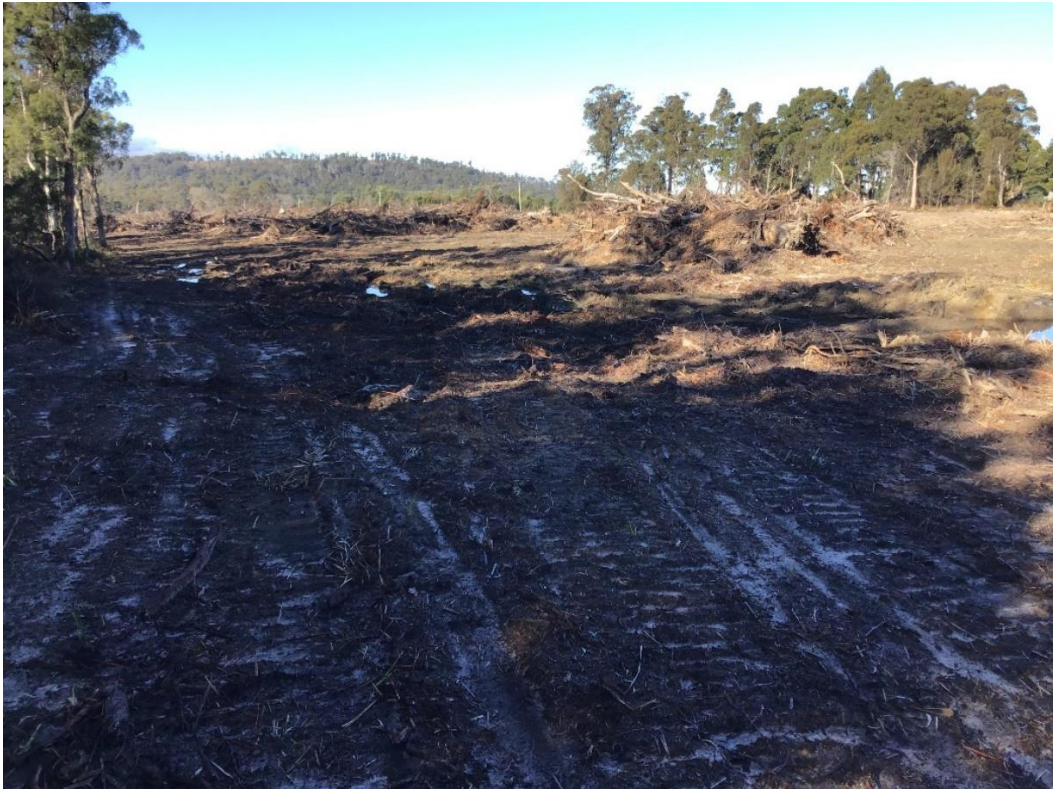
Figure 3 Current condition of the land present on the site of the proposed development

At the time of the site visit by the report author (July 2020) the land was in a semi-prepared condition with land cleared of forest and the time residue piled into log heaps ready for burning.

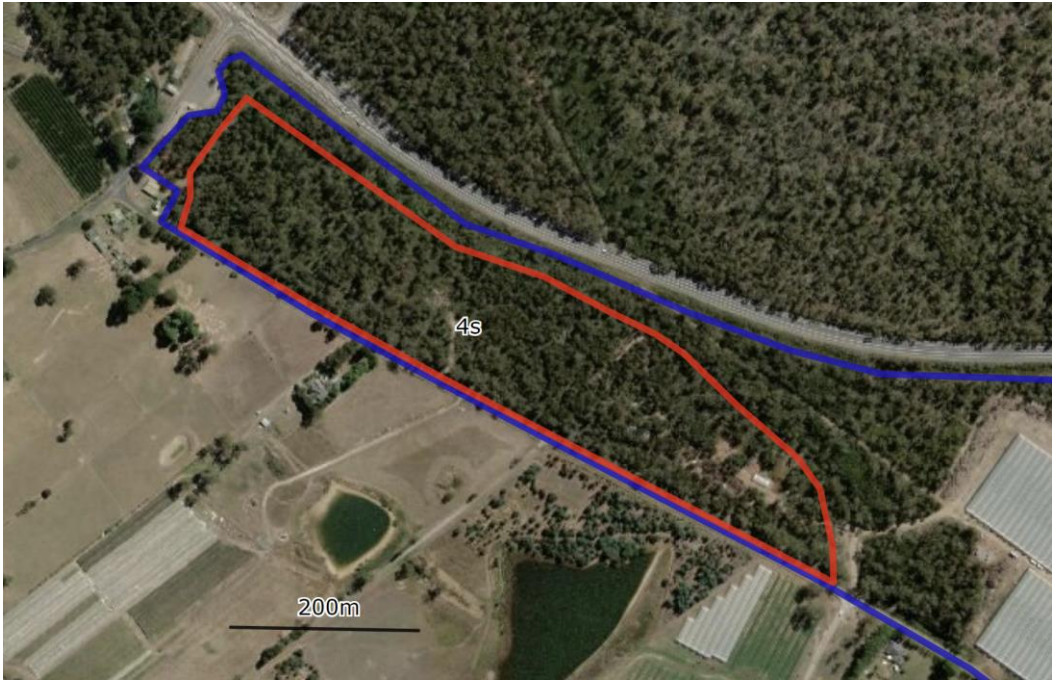
Figure 4 Land capability present on the subject development area

A more detailed, site specific assessment of land classification of the property proposed for development was undertaken by the author and confirmed that it is Class 4s.

- Soils (s) associated with the shallow topsoil depth, imperfect drainage and texture contrast between the top and sub soil

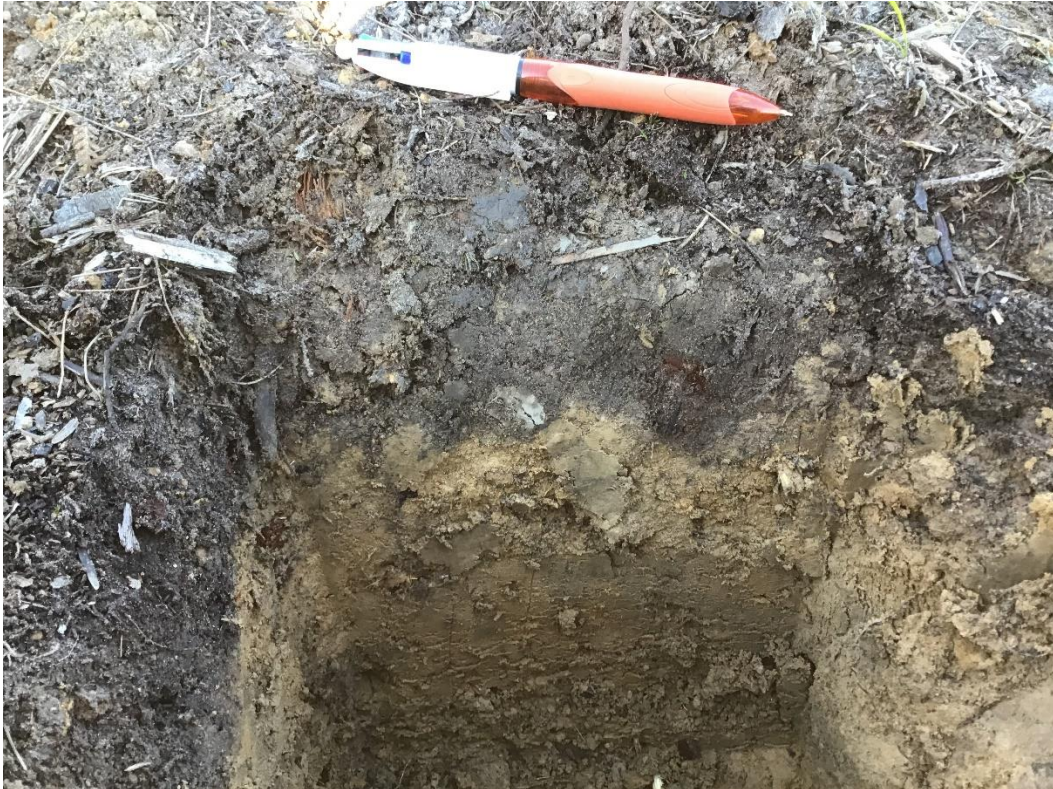
Figure 5 Brown sandy clay loam over yellow/brown clay subsoil, as per the Legana soil association

The soil present on the area of the subject to the development is a grey sandy clay loam, Podzol, imperfectly drained over alluvium deposits and is consistent with the Legana soil association.

The soil profile transitions from the grey sandy clay loam topsoil to a brown/yellow clay in the subsoil.

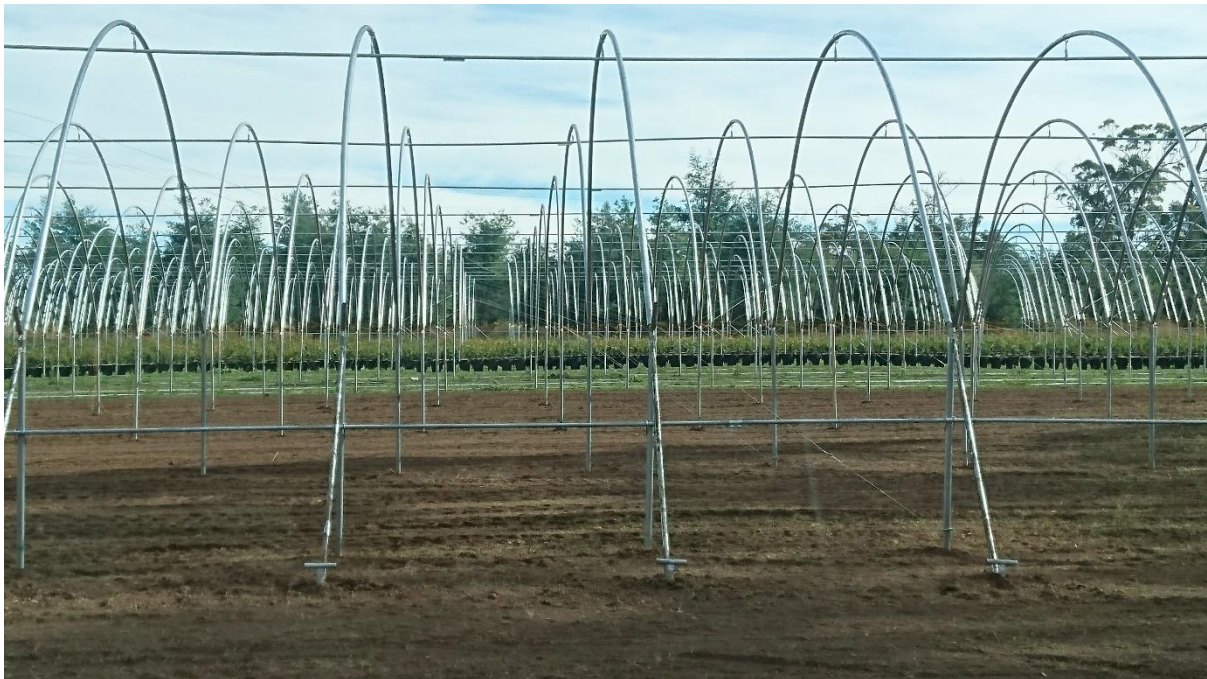
Figure 6 Tunnel structure framework and footings

No further movement of soil is required for the construction of the tunnels. The footings for the tunnel structures requires minimal excavation or soil disturbance, this is demonstrated in Figure 6.

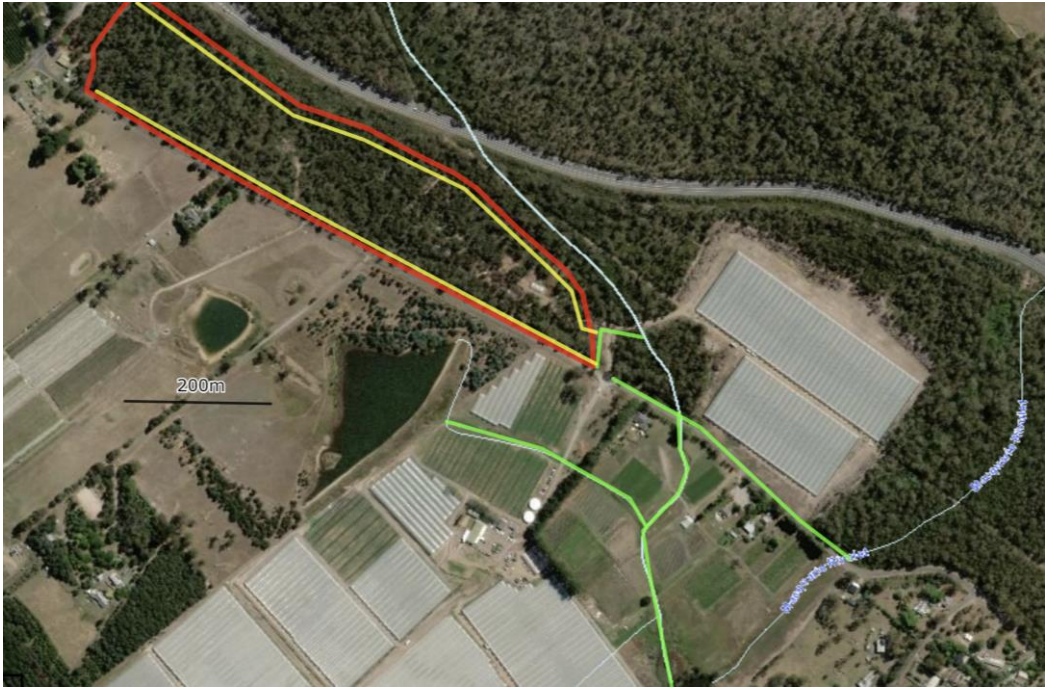
Figure 7 Existing drains (green lines) and proposed new drains (yellow lines) on the development area (outlined in red) and adjacent property (as 105 Hillwood Road) and waterways present (blue line)

Once the development site is sown down it is expected that negligible sediment would flow into these drains, however the drains should be inspected annually in March and in September to check for sediment build up and as required clean the drains out to ensure they are correctly flowing.

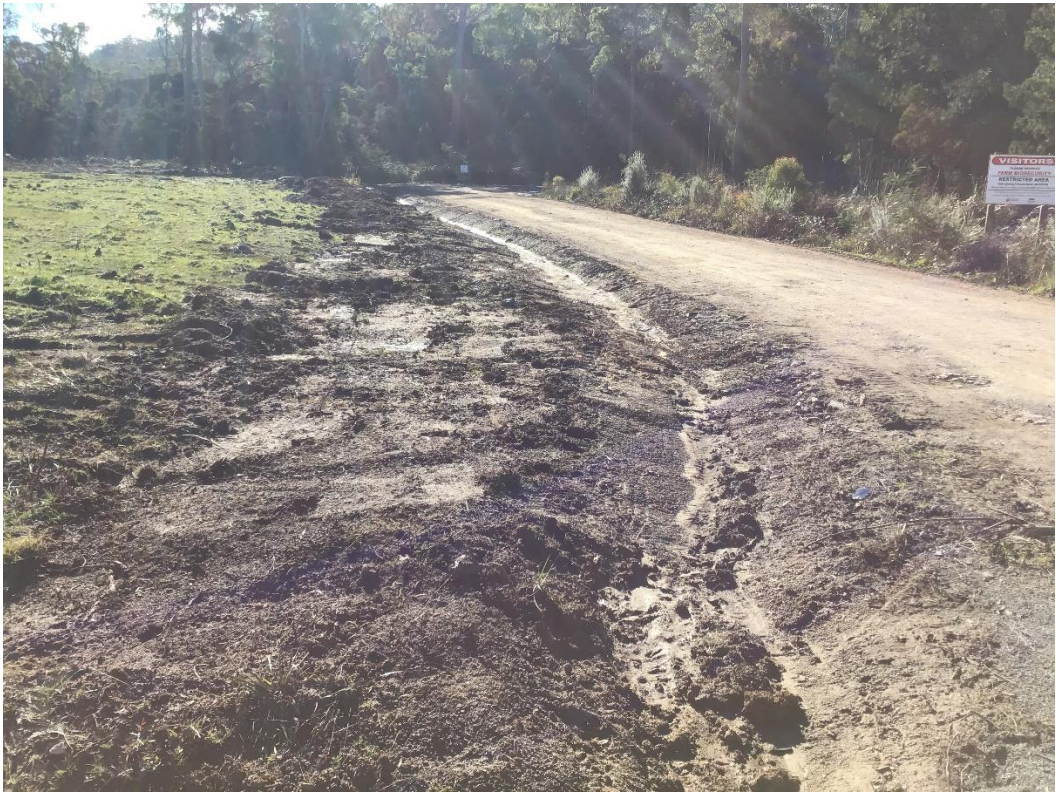
Figure 8 Current drain located at the southern end of the development area which directs runoff from Hillwood Road into the Macquarie Rivulet
